NUMBER
072A (Rev 2, 2/12/2018)

MODEL
2017MY
Multiple Models
2016-2017MY
Optima (JF)

TECHNICAL SERVICE BULLETIN

SUBJECT: SERVICE ACTION: INHIBITOR SWITCH REPLACEMENT (SA317A)

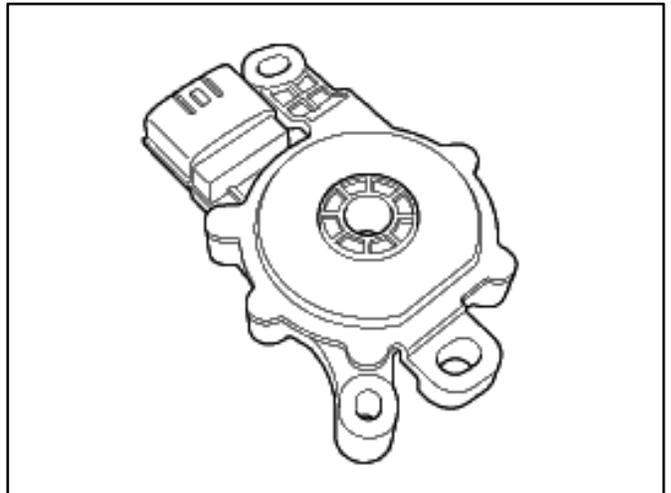
This bulletin provides the procedure to replace the inhibitor switch on some 2017MY Optima (JFa), Sorento (UMa), Optima Hybrid (HEV), Optima Plug-in Hybrid (PHEV), Sportage (QL), Forte (YD), and Sedona (YP), and some 2016-2017MY Optima (JF) vehicles, equipped with a front wheel drive 6-speed transmission, which may experience the concerns listed below. These concerns may be due to the inhibitor switch not allowing the correct gear position signal to be sent to various control units. Follow the procedure outlined in this bulletin to replace the inhibitor switch. Before conducting the procedure, verify that the vehicle is included in the list of affected VINs.

- Malfunction Indicator Lamp (MIL) ON with DTC P0705 - Transmission Range Sensor (TRS) Circuit Malfunction (active or history)
- CAN-related DTCs (For both Hybrids: CAN DTC C2243)
- Intermittent no crank/no start
- Erratic or harsh shifting
- EPB and Hold lights illuminated intermittently
- "Key OFF" indicated after placing the selector lever into the 'P' position and depressing the Start/Stop button

1. Replace the inhibitor switch by referring to the “Automatic Transaxle System → Automatic Transaxle Control System → Inhibitor Switch → Repair procedures” chapter of the applicable Shop Manual on KGIS.

2. Clear any related DTCs if necessary.
3. Confirm proper operation of vehicle.
